## ADHESION DEGRADATION OF THE METALLIZATION-ENCAPSULANT INTERFACE

Nick Bosco<sup>1</sup>, Peter Hacke<sup>1</sup>, Sarah Kurtz<sup>1</sup>, Jared Tracy<sup>2</sup> and Reinhold H Dauskardt<sup>2</sup>

<sup>1</sup>National Renewable Energy Laboratory, Golden Colorado USA

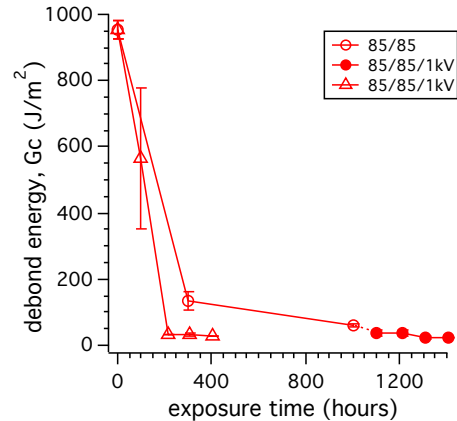
Only two of the samples under test are currently reported. The initial adhesion of the pristine Ag/EVA interface was measured to be  $952 \pm 26 \text{ J/m}^2$ . The adhesion rapidly drops with damp heat-only exposure, falling to  $134 \pm 30 \text{ J/m}^2$  following 300 hours, and then apparently plateaus around  $\sim 60 \text{ J/m}^2$  following the 1000 hour exposure. When the PID stress is introduced the adhesion continues to drop, again apparently plateauing  $\sim 25 \text{ J/m}^2$  following the additional 400 hour exposure. Adhesion of the sample that was initially exposed to the combination of 85°C, 85%RH, -1kV quickly dropped to  $33 \pm 2 \text{ J/m}^2$  following just 200 hours of exposure. Chemical analysis of the resulting delaminated surface is currently underway.

Adhesion degradation of the EVA/metallization interface has been characterized through damp heat and PID stress exposures. Preliminary results indicate that while adhesion at this interface is severely compromised by a short damp heat stress, it quickly reaches a plateau that persists with further, prolonged, damp heat exposure. The addition of a sequential PID stress also appears capable of further degrading the adhesion of this interface below this plateau level. However, simultaneous exposure of both a damp heat and voltage stress accomplishes a similar amount of degradation in only a few hundred hours. Exposures and measurements in progress at the time of abstract submission will extend these results through additional temperature and humidity conditions and additional PID stress exposures.
